**THE CALIFORNIA DEPARTMENT OF FOOD AND AGRICULTURE
HYDRILLA ERADICATION PROGRAM
ANNUAL PROGRESS REPORT 2010**

PROTECTING CALIFORNIA'S WATERWAYS

Prepared by Patrick Akers, Supervising Scientist,
with the assistance of Program Staff

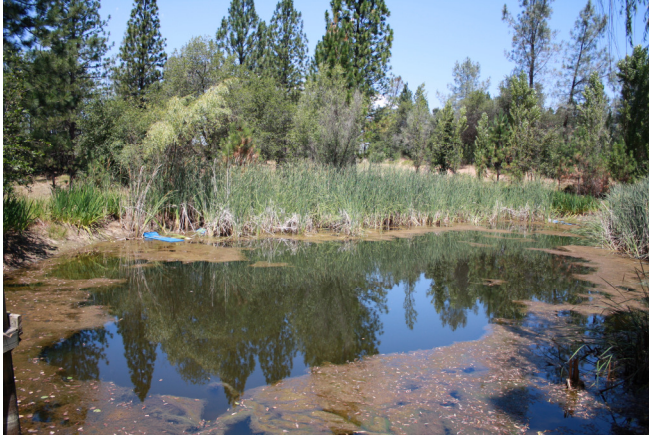
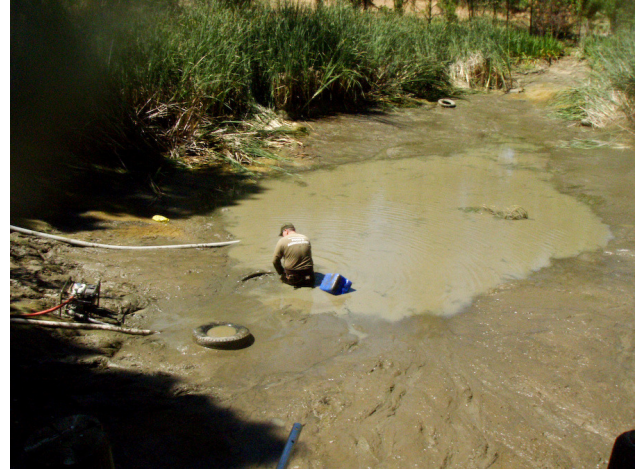
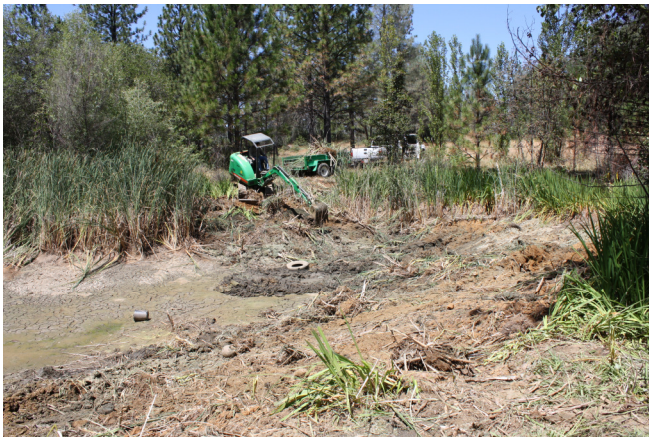
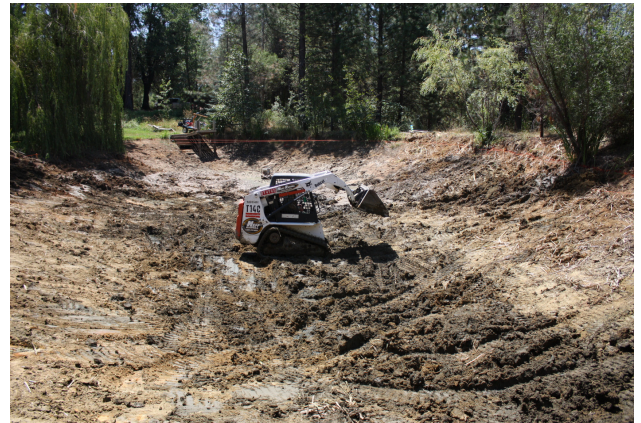
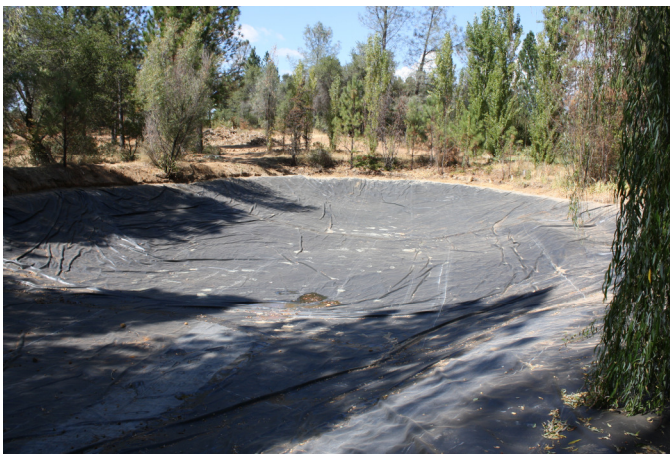
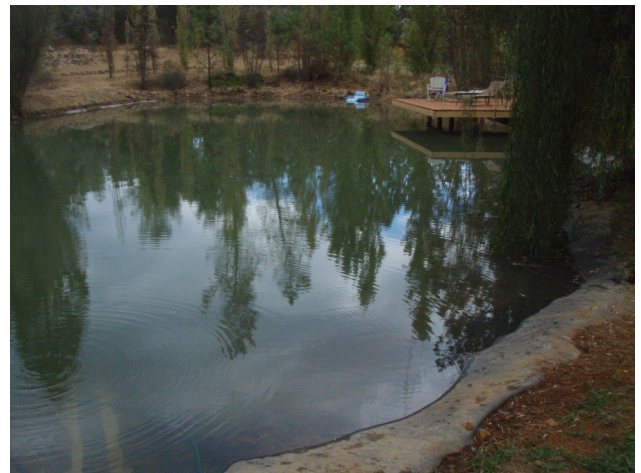
Plate 14: Lining Citron Pond. Left to right and top to bottom: Before treatment; draining the pond; removing cattails and irises; contouring the pond bottom; spreading the liner; after treatment.

Several ponds have received special treatments in recent years. The big change this year was in Citron Pond. Project biologists, working with the land owner, decided to line the pond. The biologist had been working with the owner to try to avoid damage to some specimen fish and landscaping plants around the pond, but the pond had a long history of persistent, heavy hydrilla populations. The Project biologist devoted a large portion of his time this season to lining the pond with a heavy synthetic rubber bottom liner, after first draining the pond, cleaning out the bottom muck, and re-contouring the pond profile (Plate 14). The liner completely seals the bottom of the pond. Though it should completely eliminate the hydrilla in the pond, Project staff plan to watch it carefully for the next few years. It is possible some hydrilla might emerge at the water's edge or if a tear develops in the liner. However, this action should put an end to the major persistent site of infestation in Oregon House, other than the canal itself.
